NASA Technical Paper 1624

Wear Particles of Single-Crystal Silicon Carbide in Vacuum

Kazuhisa Miyoshi and Donald H. Buckley
Lewis Research Center
Cleveland, Ohio

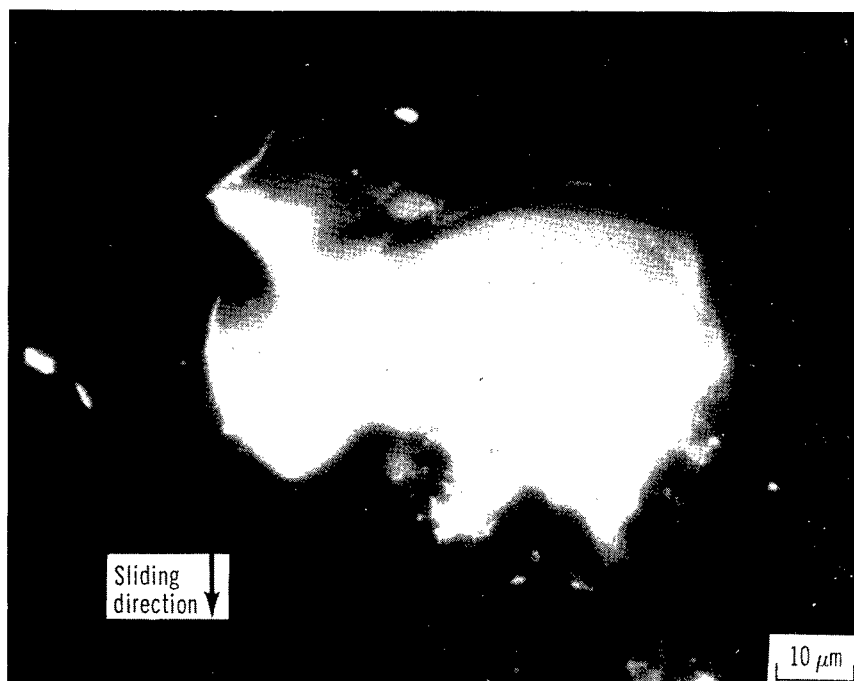
Figure 4. - Large fracture pit of single-crystal silicon carbide in contact with 8.12 atomic percent Ti-Fe alloy as a result of ten passes of rider in vacuum (10^{-8} Pa). A scanning electron micrograph of wear track on silicon carbide (0001) surface. Sliding velocity, 3×10^{-3} meter per minute; load, 0.2 newton; room temperature.

Figure 4 presents a scanning electron micrograph of a wear track on a silicon carbide surface accompanied by an exceptionally large fracture pit. A large light area at the beginning of wear track is a fracture pit where the wear track was generated by 10-pass sliding of a 8.12 atomic percent titanium-iron alloy rider across the surface. Most of the silicon carbide wear debris has already been ejected from the wear track. The smooth surface at the bottom of the fracture pit is due to subsurface cleavage along $\{0001\}$ planes.

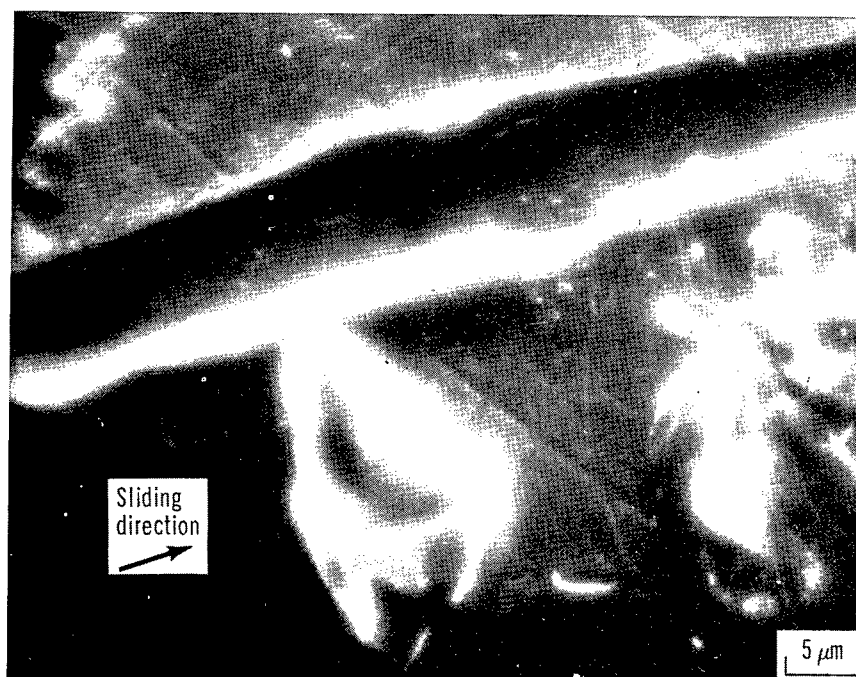
(a) Grooves and spherical indentations.

(b) Groove.

Figure 9. - Grooves and indentations formed by plowing and indenting of spherical wear debris as result of ten passes of rider in vacuum (10^{-8} Pa). Scanning electron micrographs of wear scar on 1.02 atomic percent Ti-Fe alloy rider. Sliding velocity, 3×10^{-3} meter per minute; load, 0.2 newton; room temperature.

Figure 9 consists of scanning electron micrographs of rider wear scars after sliding against a silicon carbide surface. These figures reveal spherical indentations and straight grooves along the sliding direction on the rider surfaces formed by indenting and plowing the spherical wear debris. Such a spherical wear particle and its indentation and groove were primarily observed for the alloys with low solute concentrations presented in table II. These results reveal that (1) a nearly spherical wear particle can be produced by sliding friction, (2) the wear particle plows the surface of the alloy rider during sliding, that is, the hardness of the particle is much greater than that of the alloy rider surface, and (3) the wear particle includes the element of silicon, as shown by the X-ray map of Si K_{α} . The next question is what is the real

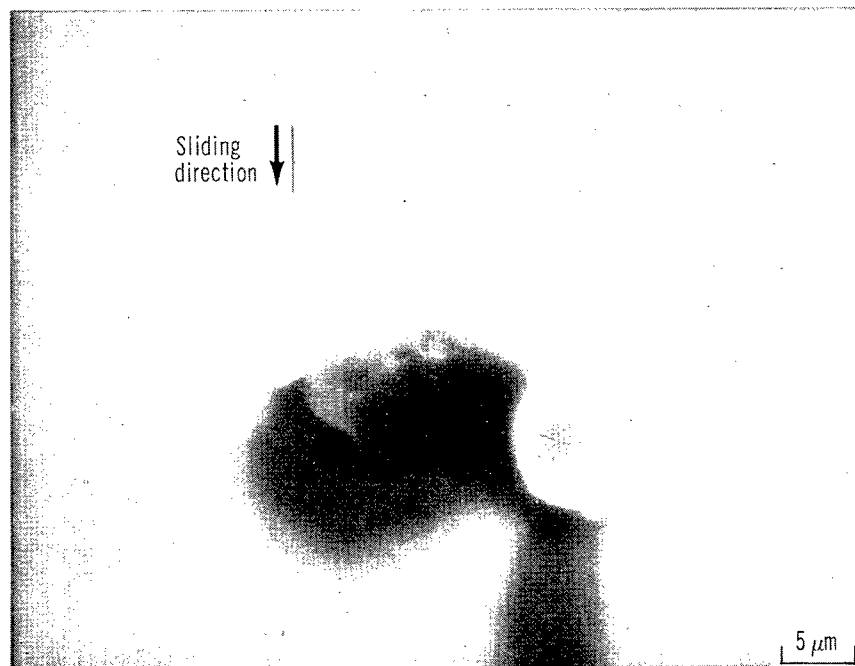
(a) Spherical wear particle.

(b) Spherical and multiangular wear debris.

Figure 10. - Spherical and partially spherical wear particle as result of ten passes of 1.02 atomic percent Ti-Fe alloy riders in vacuum (10^{-8} Pa). Scanning electron micrographs of wear tracks on disk. Sliding velocity, 3×10^{-3} meter per minute; load, 0.2 newton; room temperature.

(c) Partially spherical and partially multiangular wear particle.

(d) Partially rounded and partially multiangular wear particle.

Figure 10 shows partially spherical wear debris particles observed on the silicon carbide surfaces in sliding contact with the 1.02 atomic percent titanium-iron alloy rider. The nearly spherical particles are very similar to the particle observed on the wear scar shown in figure 8. The partially spherical wear particles include a multiangular and a spherical portion. Partially spherical wear particles were also observed with the multiangular wear debris particles on the wear scar of the alloy, as shown in figure 11.

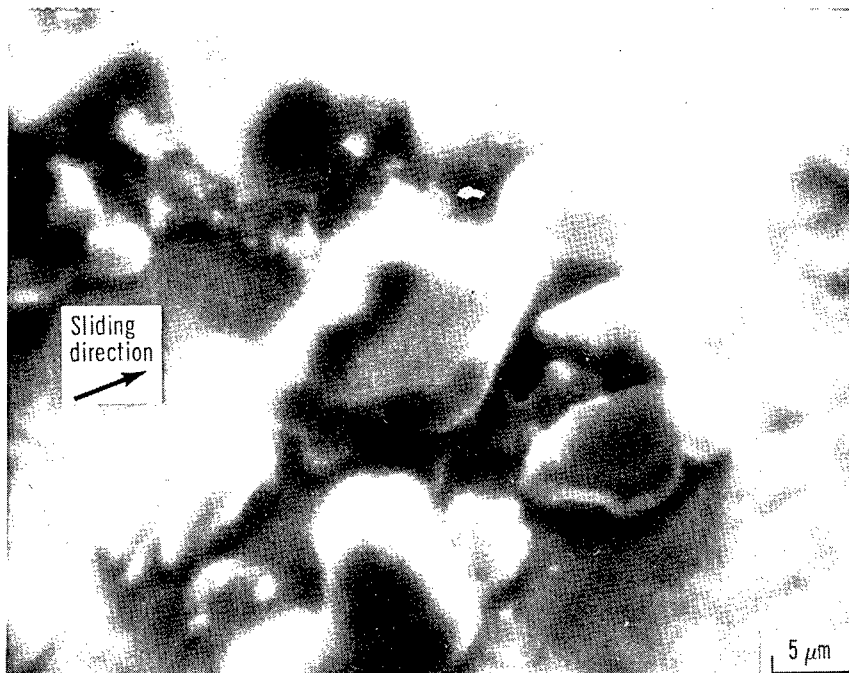
Figure 11. - Partially spherical wear particle and multiangular wear particles as result of ten passes of 1.02 atomic percent Ti-Fe alloy rider in vacuum (10^{-8} Pa). Scanning electron micrograph of wear scar on alloy rider. Sliding velocity, 3×10^{-3} meter per minute; load, 0.2 newton; room temperature.
